# Bridging and Chipping of Coatings

# PROBLEM

## Coating edges are chipped

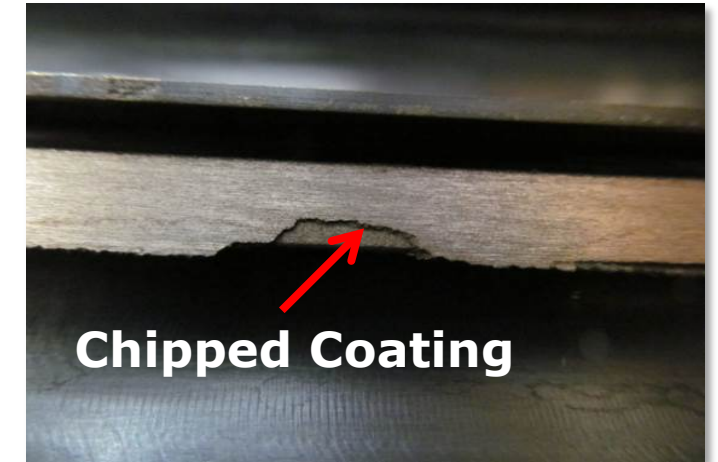
- Extra time required to repair or re-work affected parts
- Higher number of rejected parts
- Increased costs

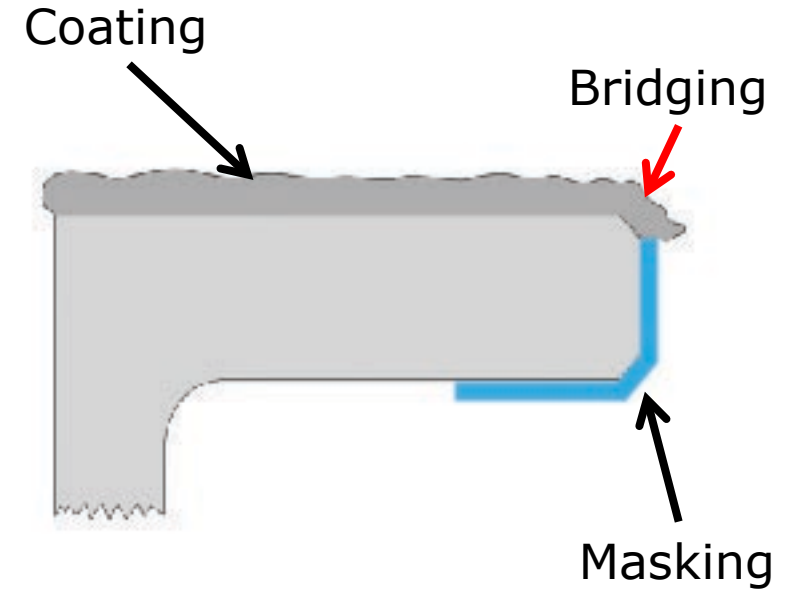
## Inferior tapes or incorrect masking strategies

- Metal masking and eroded tapes may lead to bridging.
- Thick tape or multiple layers of tape cause ledging and bridging.

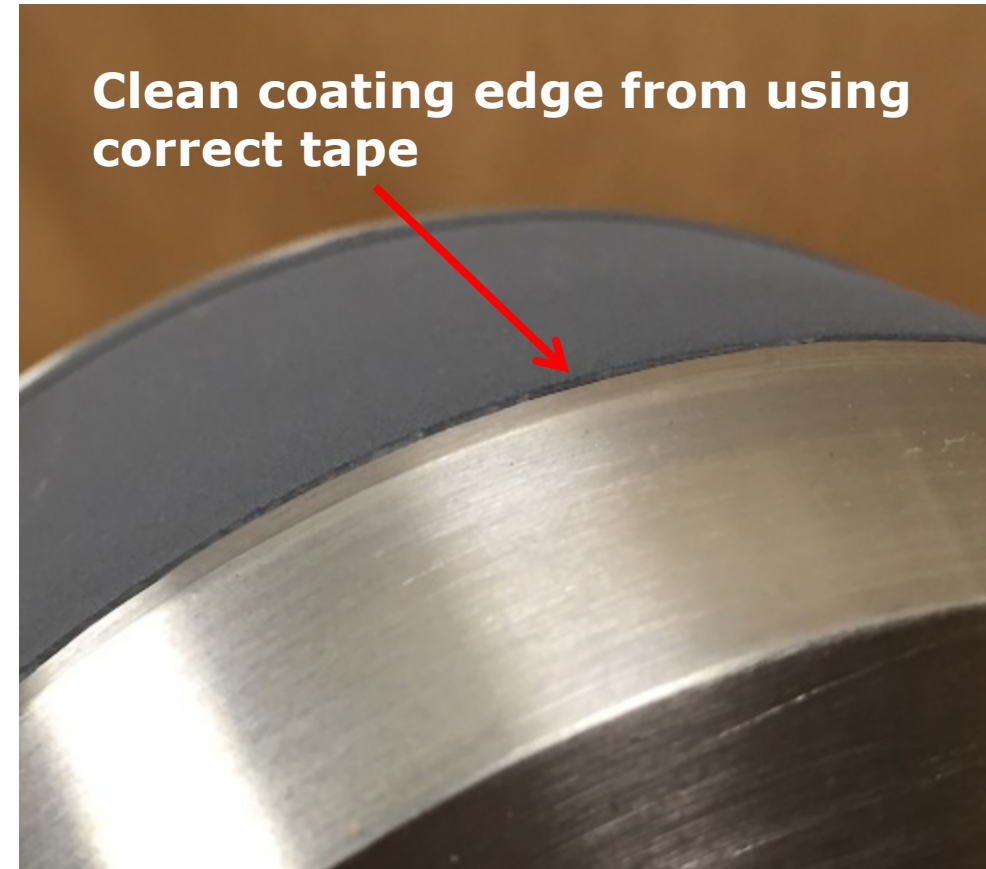
- Low profile masking prevents ledging and bridging.
- High tensile strength allows for single layer use.
- Tape with well defined edging.

Tip: For critical jobs use a ½" wide "sacrificial" layer of tape to be removed after grit blast (or removed during spraying process)

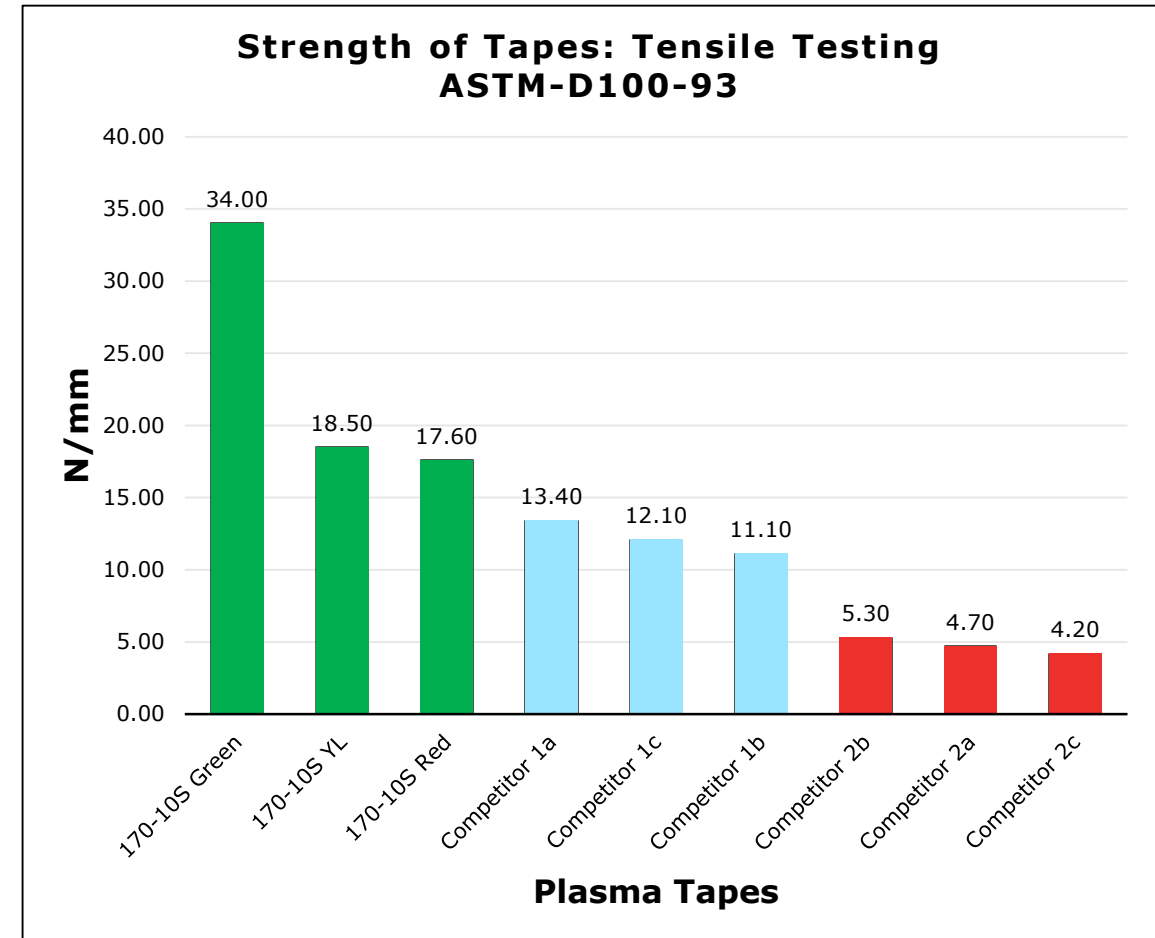
- Higher tensile strength can allow for fewer tape layers, keeping the masking profile as thin as possible.
- Green Belting Masking tapes have high tensile strength.

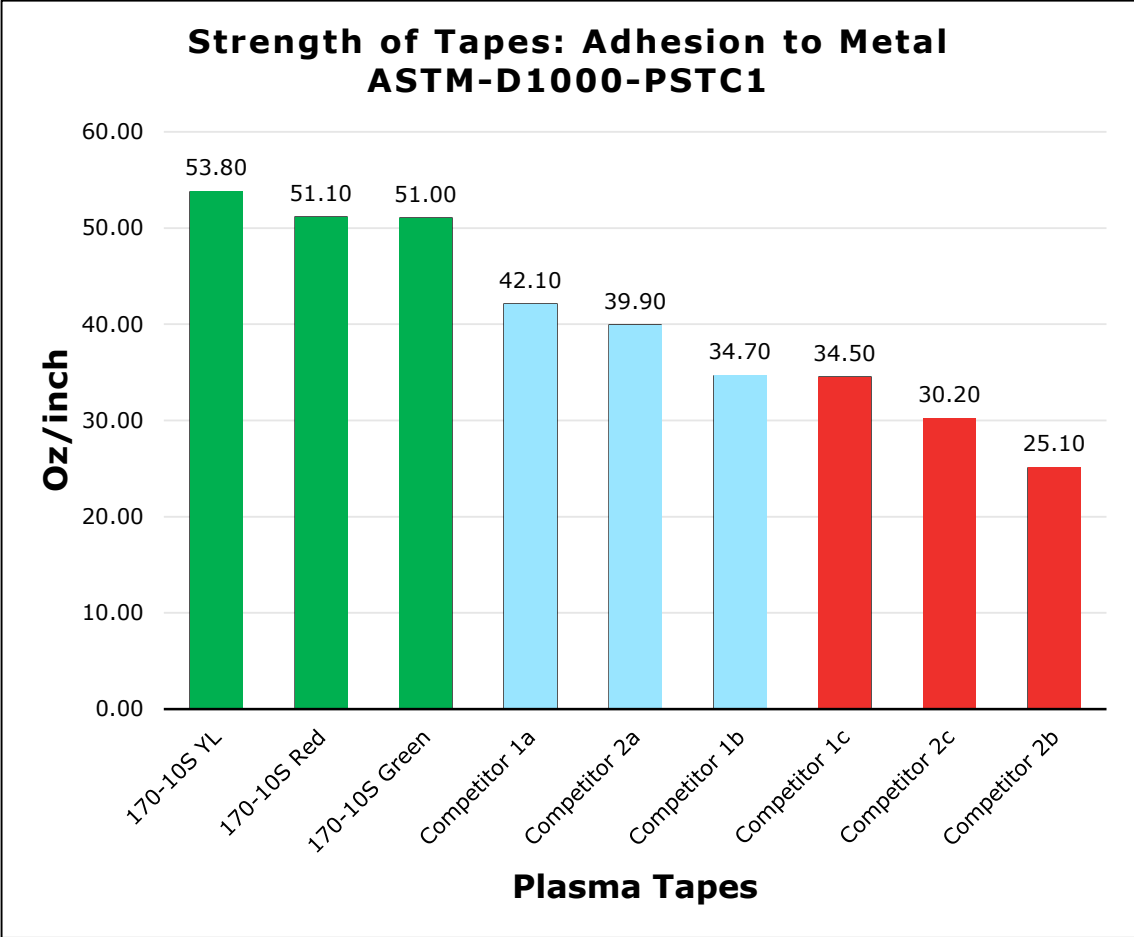
**Green Belting tapes have stronger adhesion so only one layer is needed!**
